DETERIORATION  
OF STRUCTURES IN  
SEA-WATER  
FIRST REPORT OF THE  
COMMITTEE OF THE INST. C.E.

COMMITTEE  
OF  
THE INSTITUTION OF CIVIL ENGINEERS  
APPOINTED TO INVESTIGATE  
THE DETERIORATION OF STRUCTURES  
OF TIMBER, METAL AND CONCRETE  
EXPOSED TO THE ACTION OF  
SEA-WATER

*FIRST REPORT OF THE COMMITTEE*

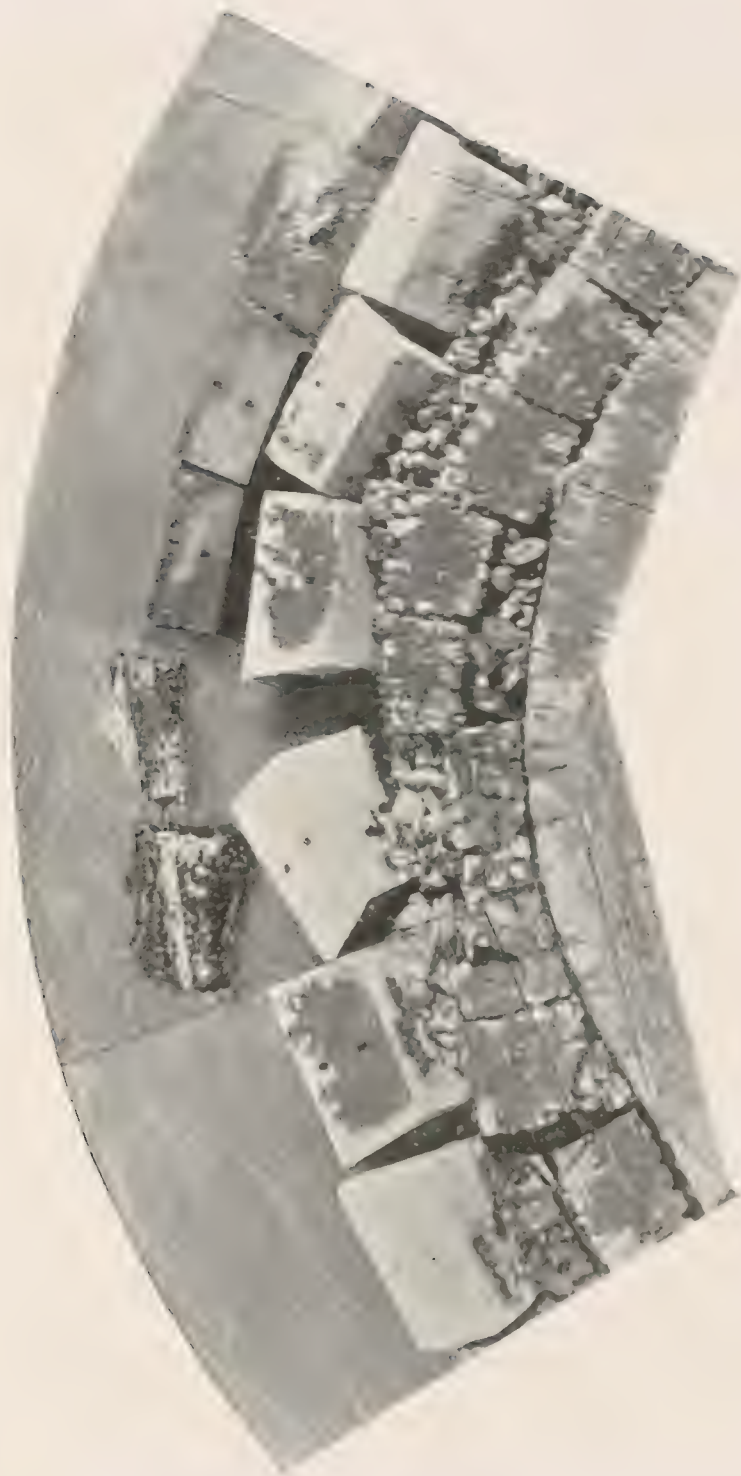
CONCRETE BLOCKS ROUND THE BASE OF POOLBEG LIGHTHOUSE.  
View from balcony of the lighthouse.

The chart, Fig. 2, which accompanies this memorandum indicates the positions of the several works referred to therein. The photograph of the concrete blocks around the base of Poolbeg Lighthouse, Plate II., shows the present condition of the blocks.

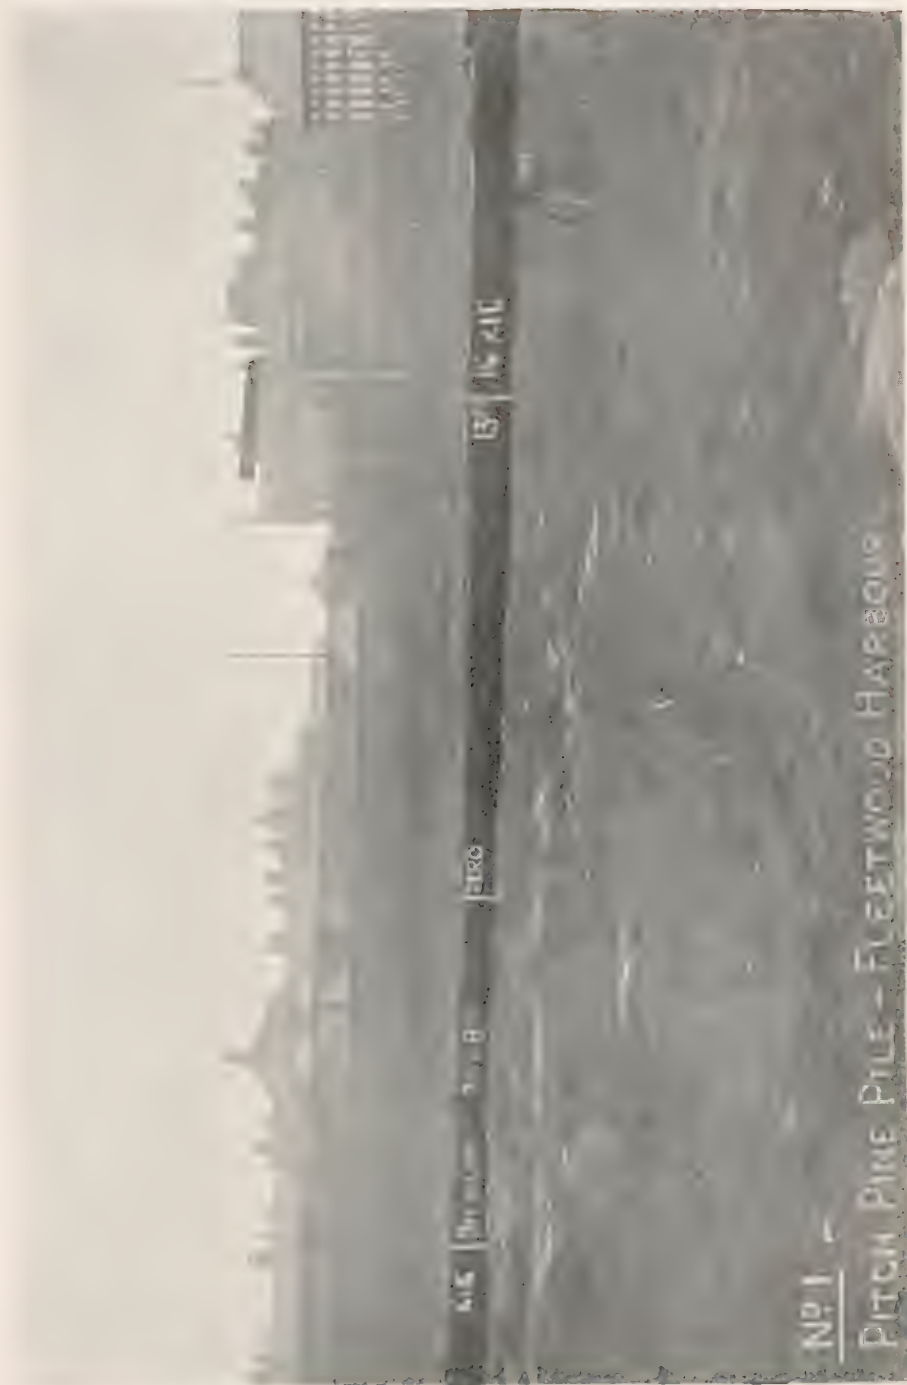
FLEETWOOD.

PILE OF PITCH PINE AT FLEETWOOD SHOWING PORTION DAMAGED BY SEA ACTION.

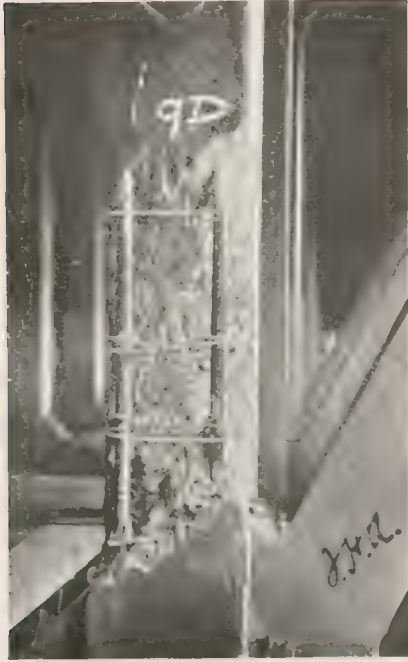
DEFECTIVE CONCRETE REMOVED TO LAY BARE REINFORCEMENT.

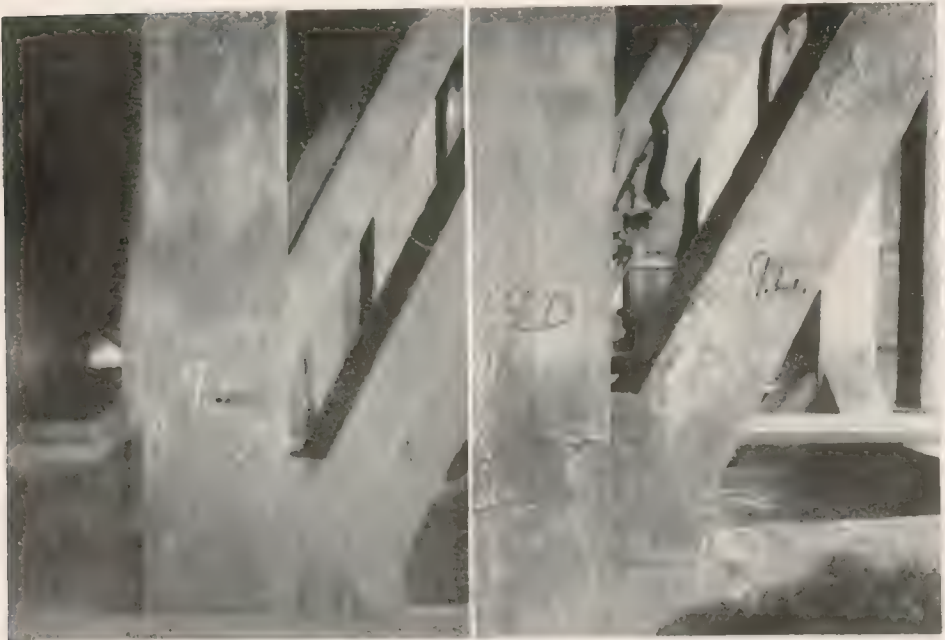
REINFORCED CONCRETE PILES AND BRACES SHOWING METHOD OF REPAIRING INJURIES.

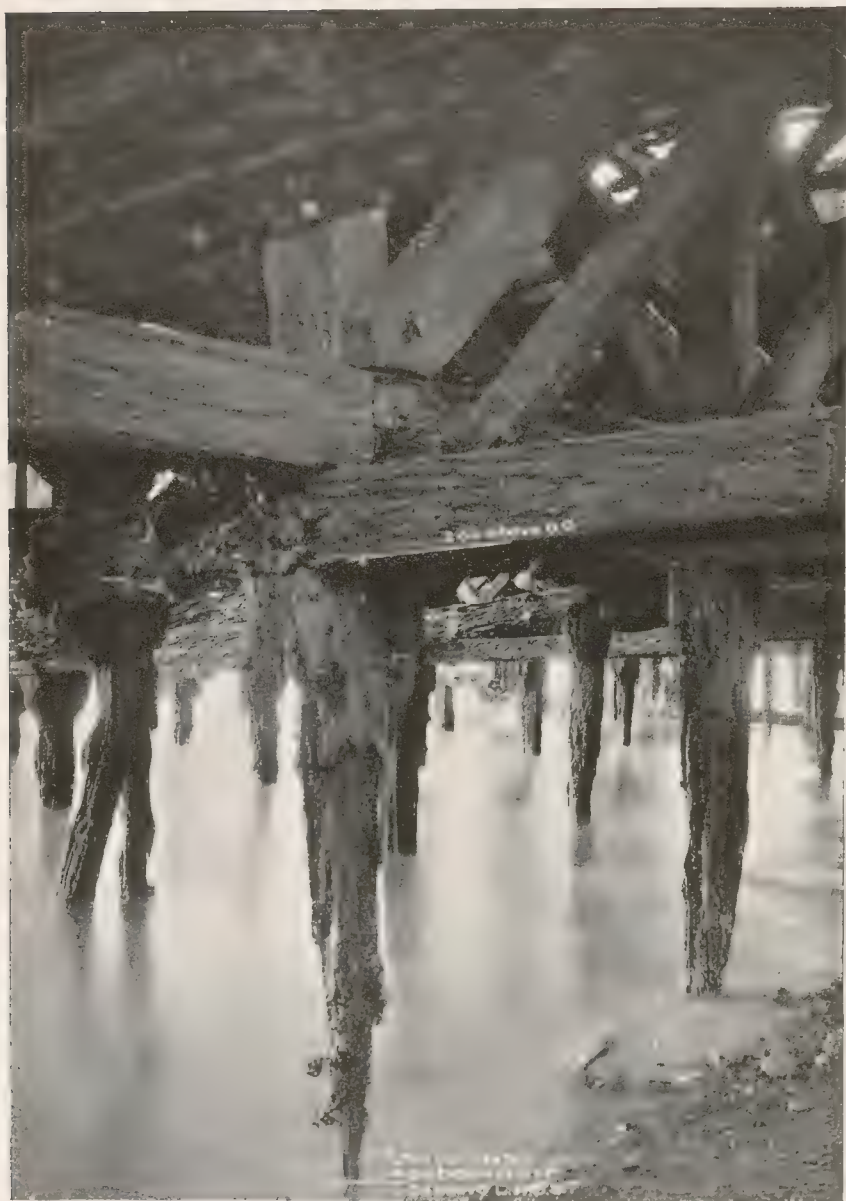
PIER "C"—GENERAL VIEW TAKEN IN 1914 OF UNCREOSOTED PITCH PINE  
PILES DRIVEN IN 1889.

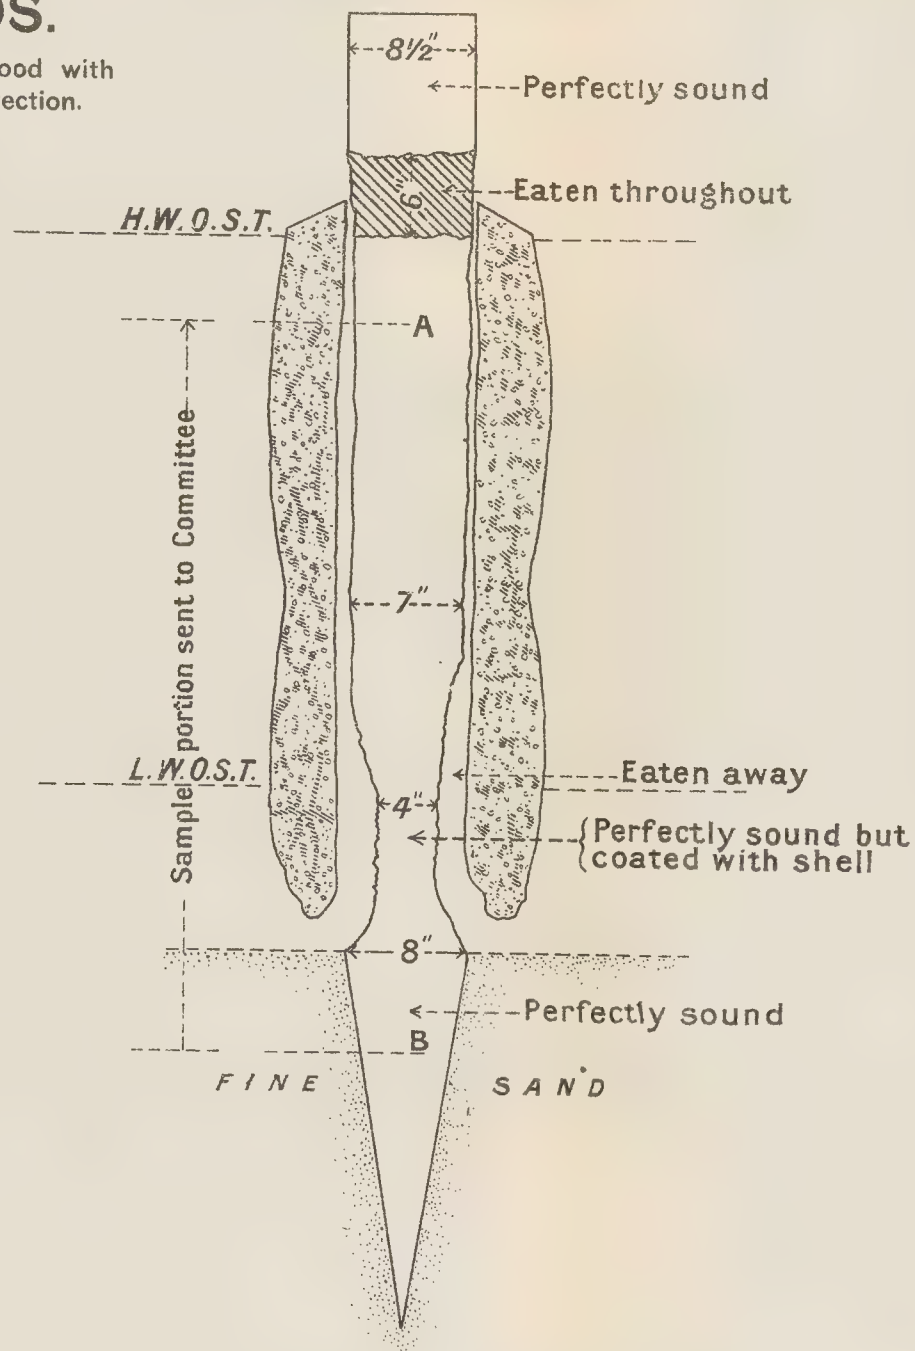
Illustrating condition of pile  
when taken out of the water.

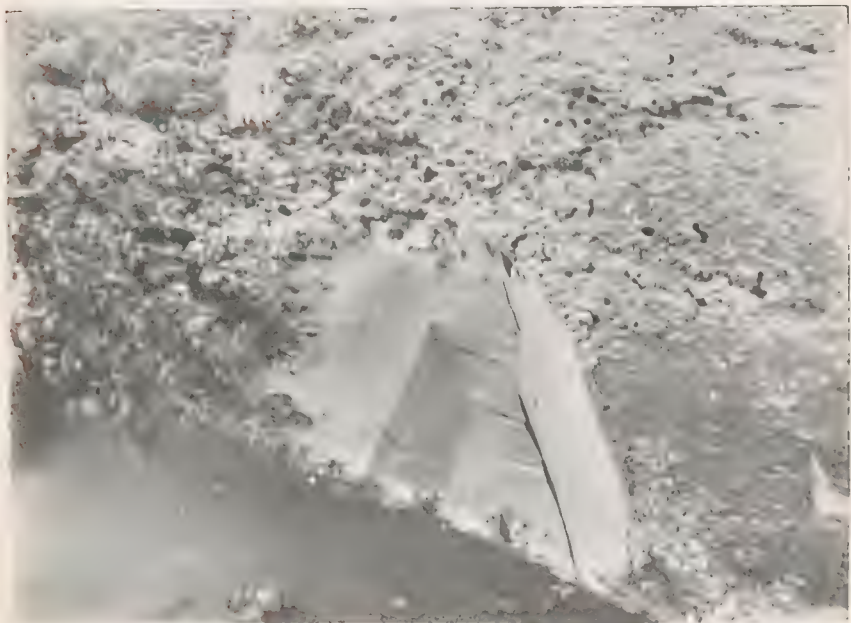
FIVE DOCK BAY TEST PILES. 12 years old.  
Unprotected turpentine pile showing limnoria and teredo holes in sapwood.  
Wood otherwise sound.

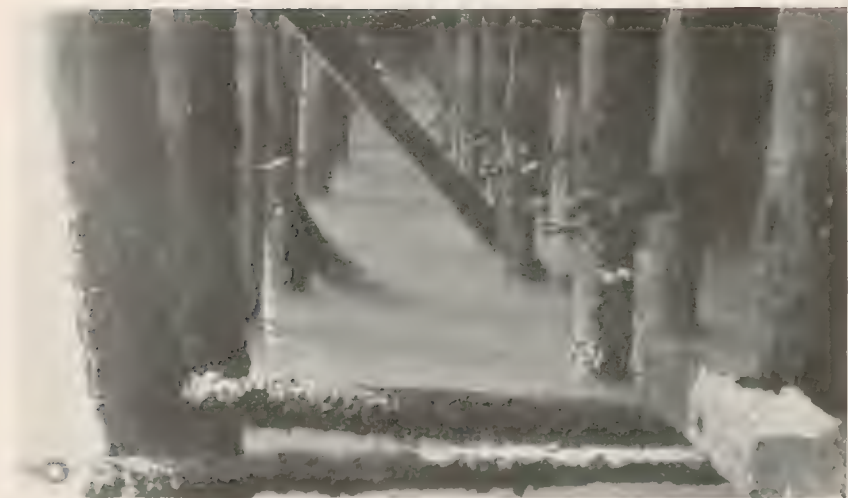
VIEW OF EAST WHARF AT LOW WATER SHOWING DECAY OF BRACINGS OF BALLOW.  
LOOKING EAST.

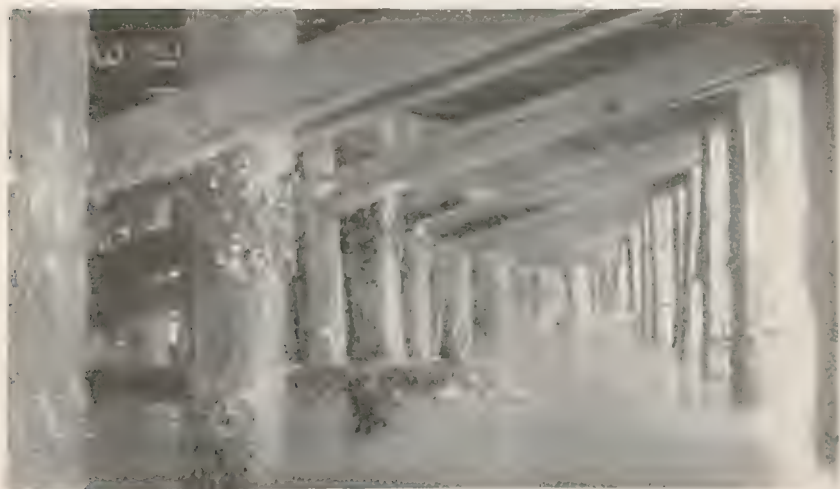
VIEW OF EAST WHARF, LOOKING WEST, SHOWING DECAY OF BRACINGS OF BALLOW.

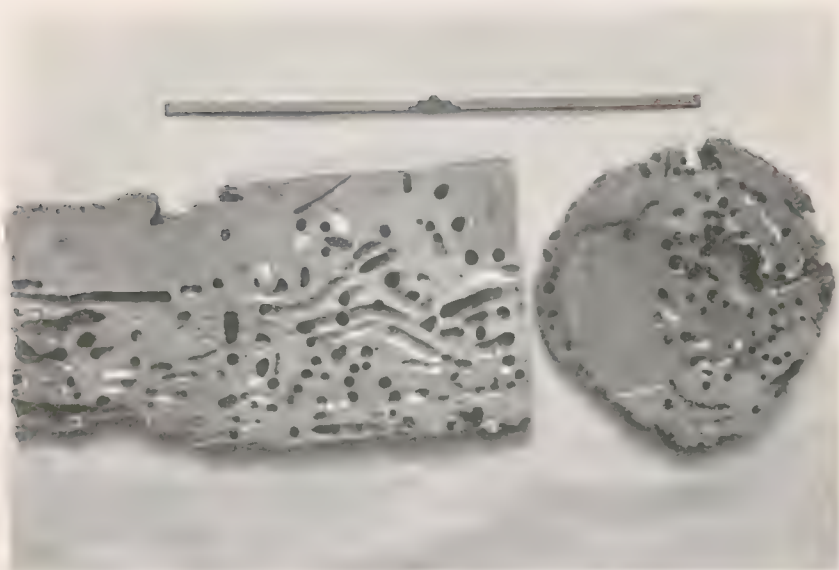
SECTIONS OF A PILE IN EAST WHARF SHOWING TEREDO ACTION.

Original section 12 inches  $\times$  6 inches. Situation, about 2 feet 6 inches above L.W.O.S.T. Holes range up to about  $\frac{3}{4}$ -inch diameter. Timber, Ballow.

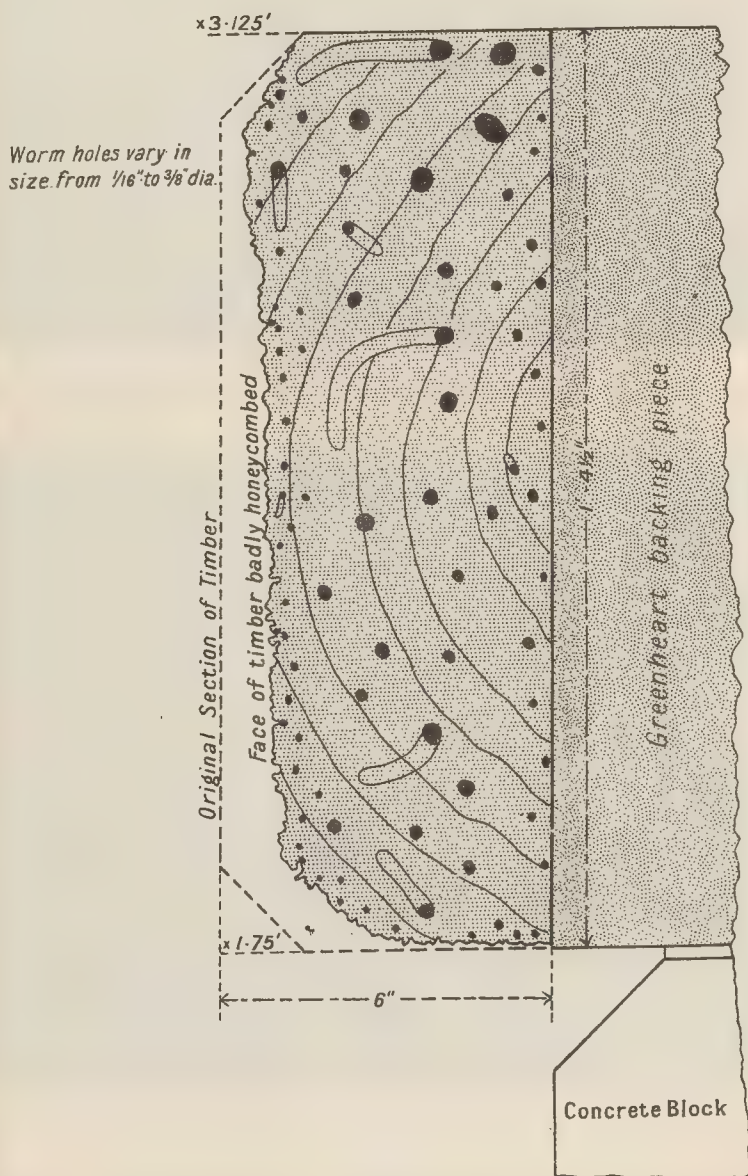
Section of Ballow Rubbing Piece  
to show teredo attack.
